June 6, 2023

Re: Structural Condition Assessment
Smith Building
113 East Main Street
Thorntown, IN

CE Solutions' Project No: 23-137

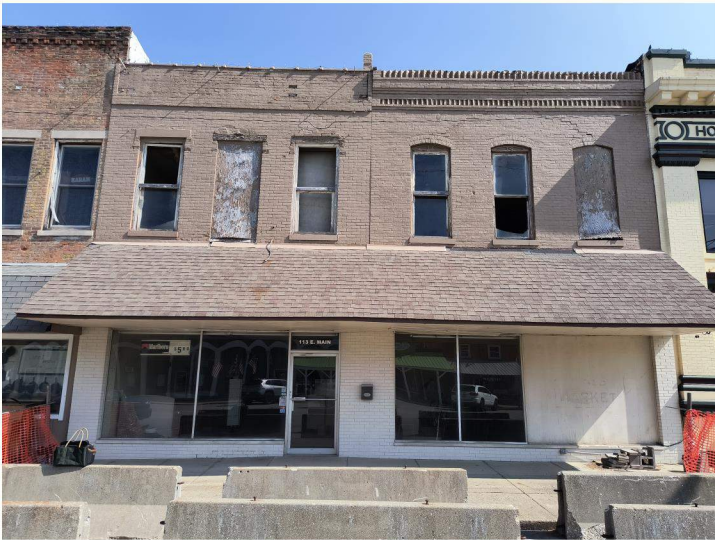
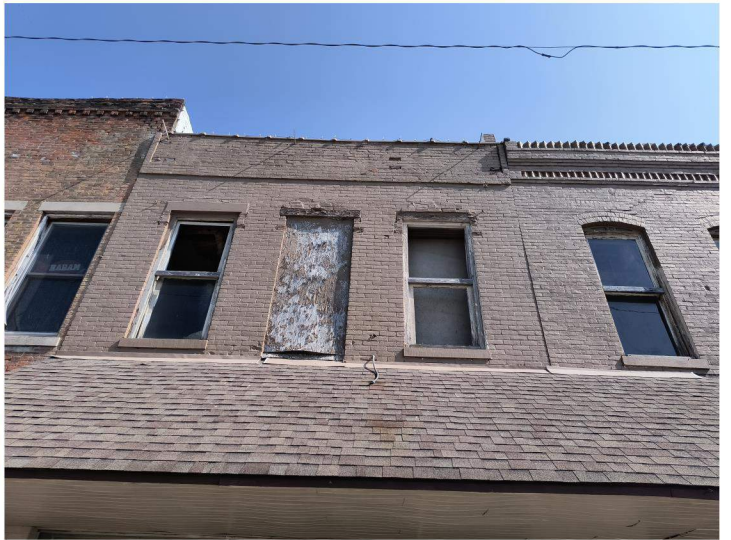
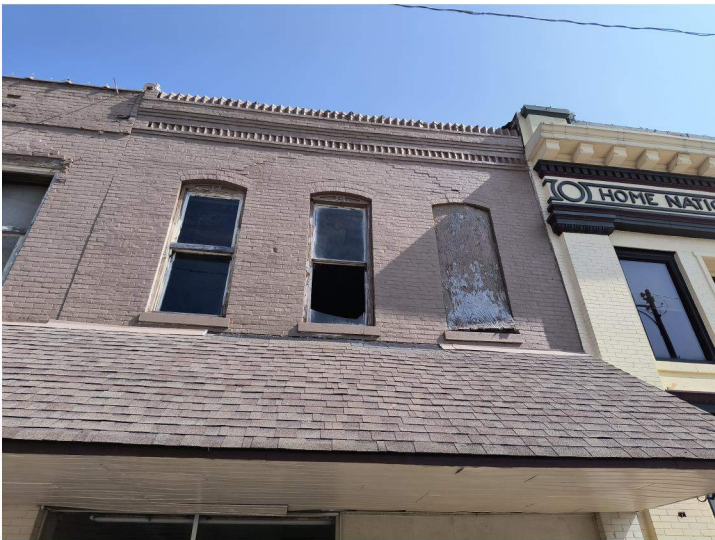
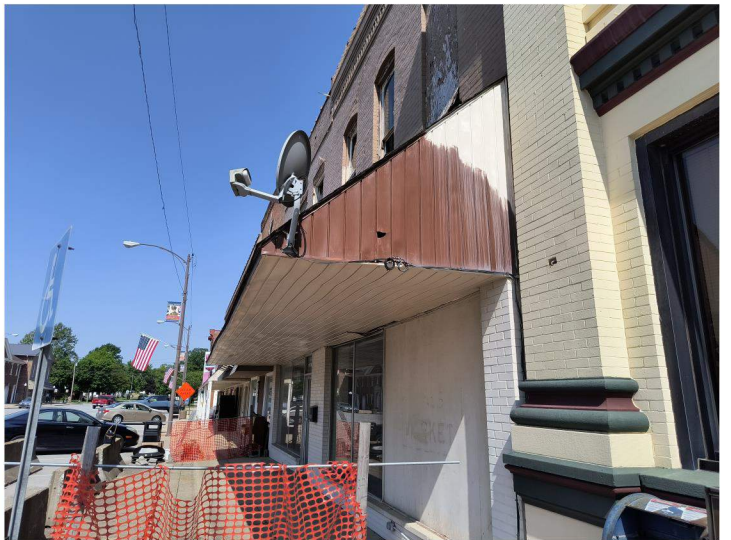
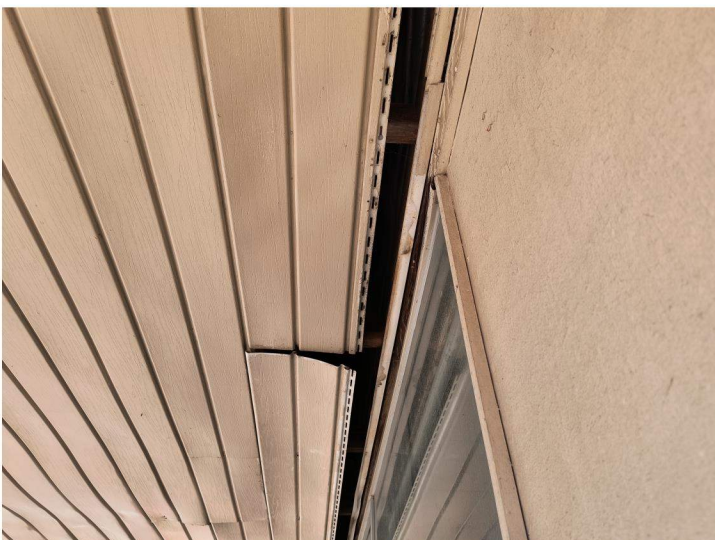
- The front brick façade appears to be in a fair condition.
- There are some diagonal cracks and slight outward displacement in the brick above the arched windows.
- Two window lintels appear to have been replaced with wood timber lintels in place of the original stone lintels.
- The front brick wall at the east building is not connected to the roof. Daylight can be seen between the roof edge and the brick wall (see photos 56 and 57). The parapet at this wall has deteriorated and failed as can be seen on the roof (see background in photo 69).
- The front canopy appears to be in a fair condition. The soffit panels have been displaced from the main building wall.
- See photos 01 through 05.

5. Replace two timber posts with notches in the basement with new timber posts.
6. Repair diagonal cracks in the brick wall above the arched window at the front wall.

7. Connect the top of the brick wall to the roof structure at the front wall with the arched windows and repair/rebuild the brick parapet above the wall.

8. Replace the two wood window lintels at the front wall with stone lintels to match the original stone lintels.
9. Repair and tuck point deteriorated mortar brick joints at the back wall. It is estimated that approximately 600 SF of brick wall where mortar joints may have to be repaired at the back wall.

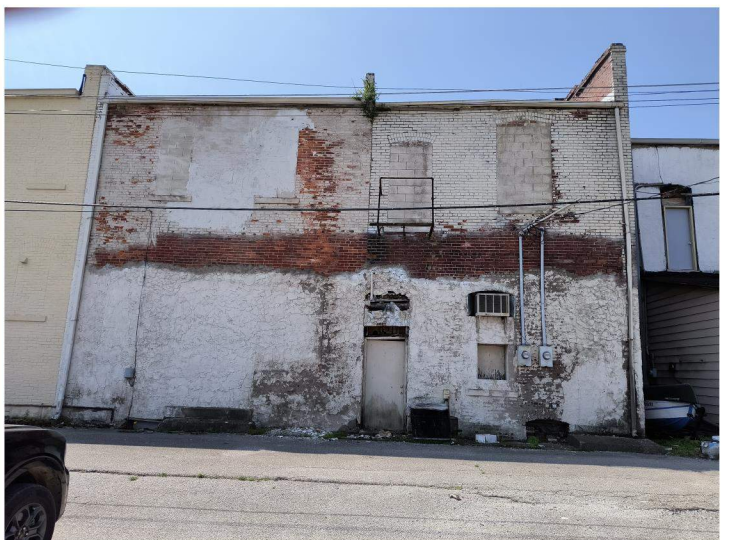
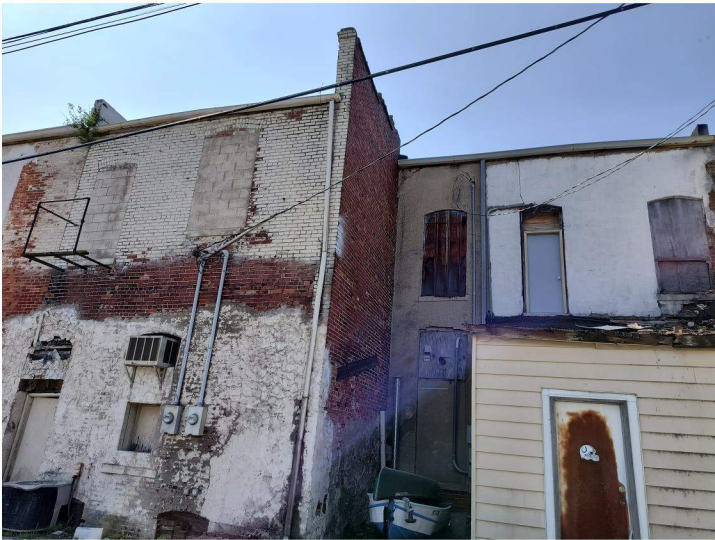
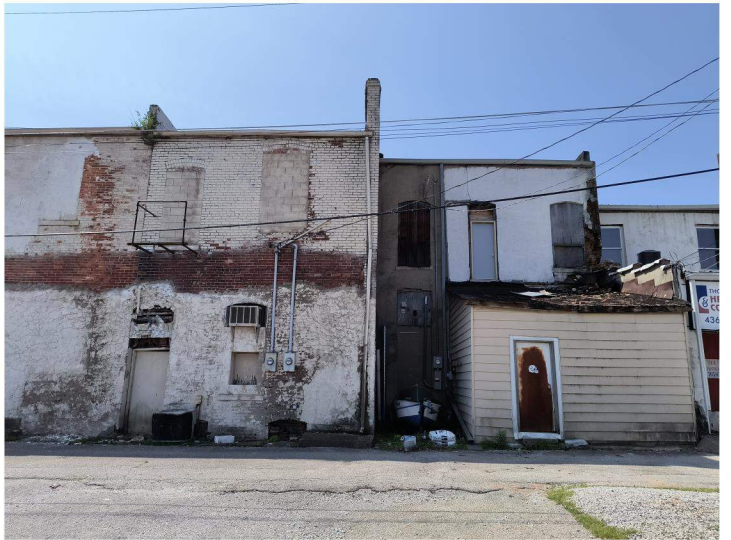
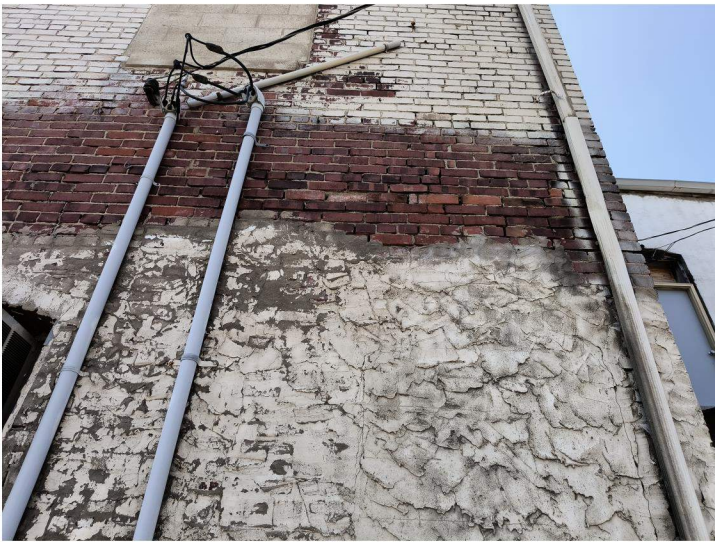
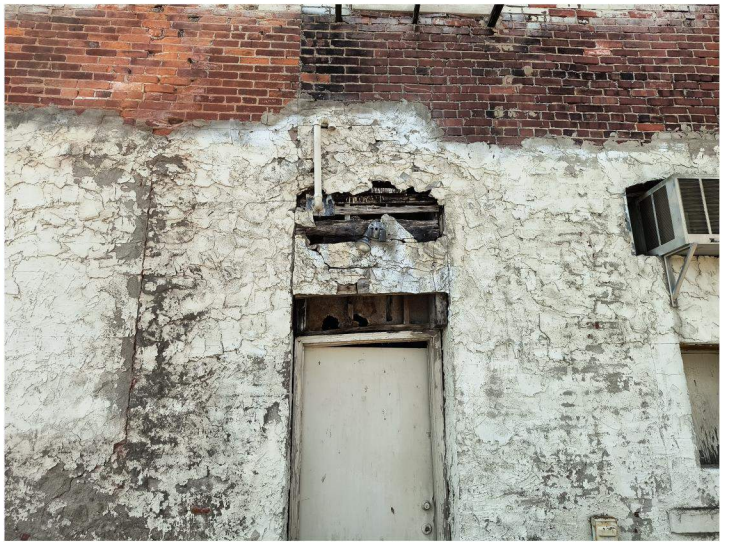
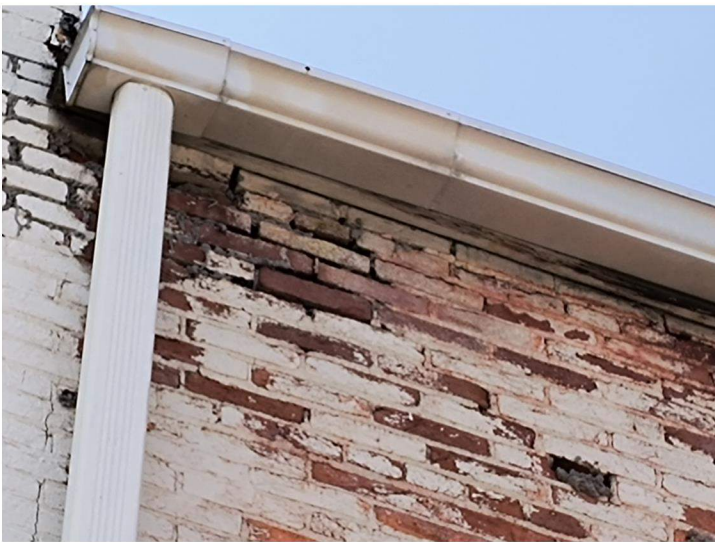
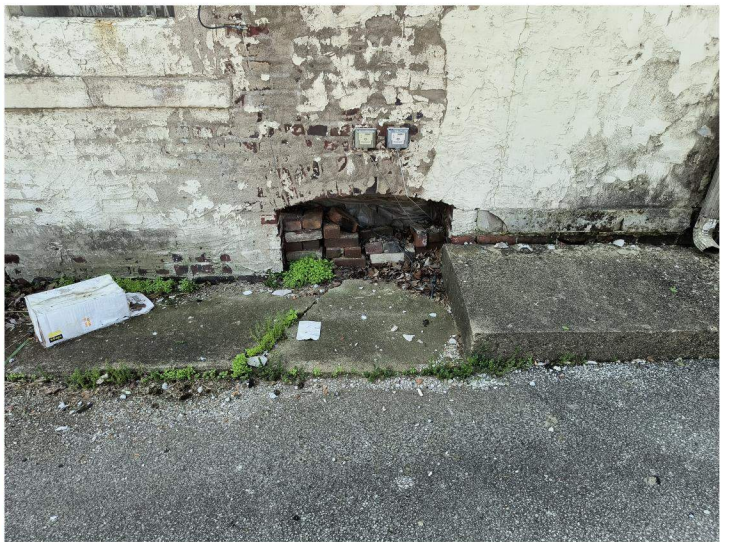
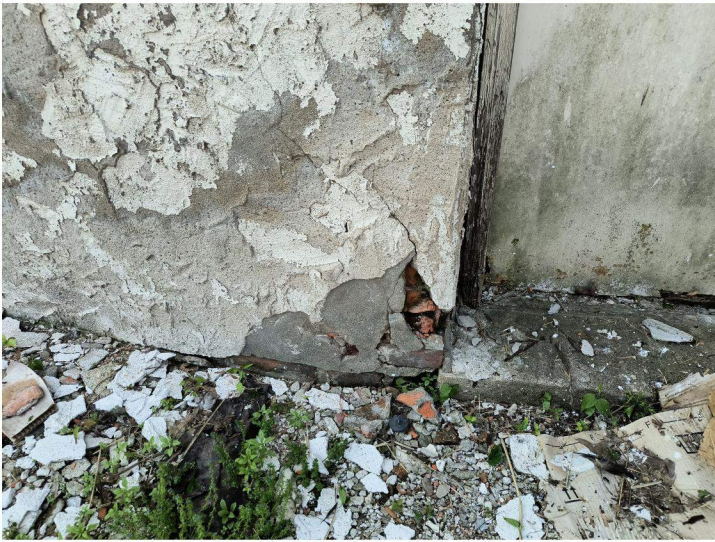
- The back brick walls appear to be in a fair to poor condition.
- The bottom half of the back wall has been plastered over perhaps due to deteriorated brick condition. The top part of the wall has been painted.
- At many locations at the back wall, the brick mortar joints have deteriorated due to moisture migration into the joints. It is difficult to assess the extent of the brick joint deterioration at the painted and plastered locations.
- See photos 06 through 13.

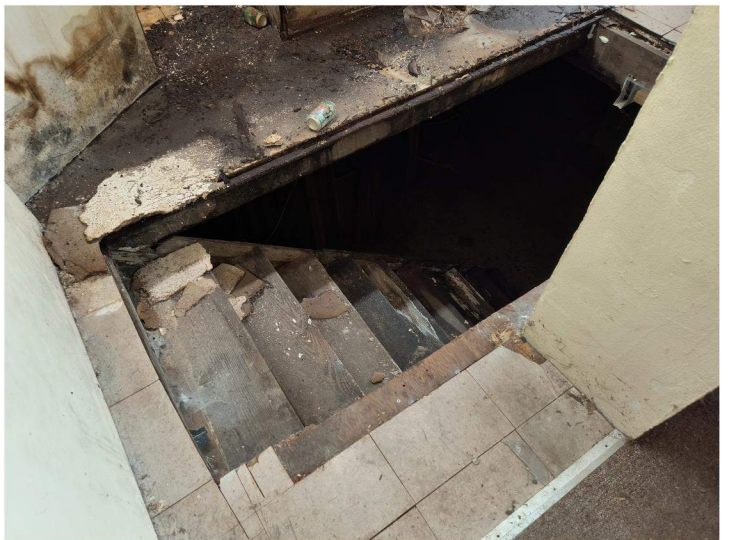
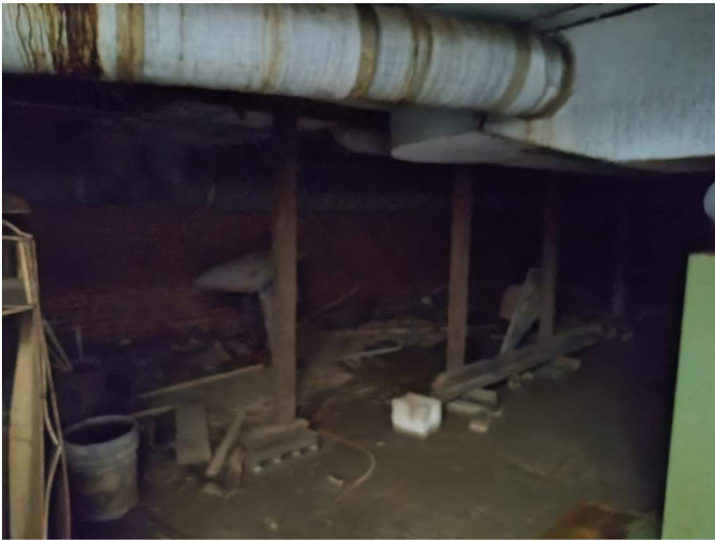
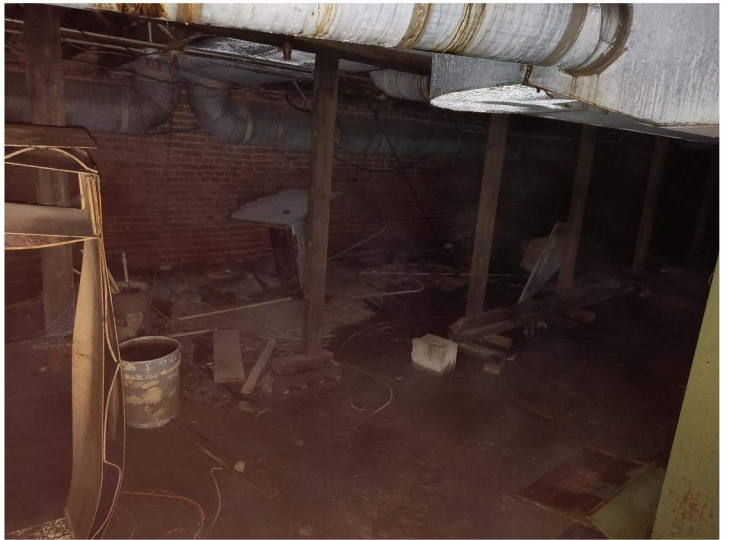
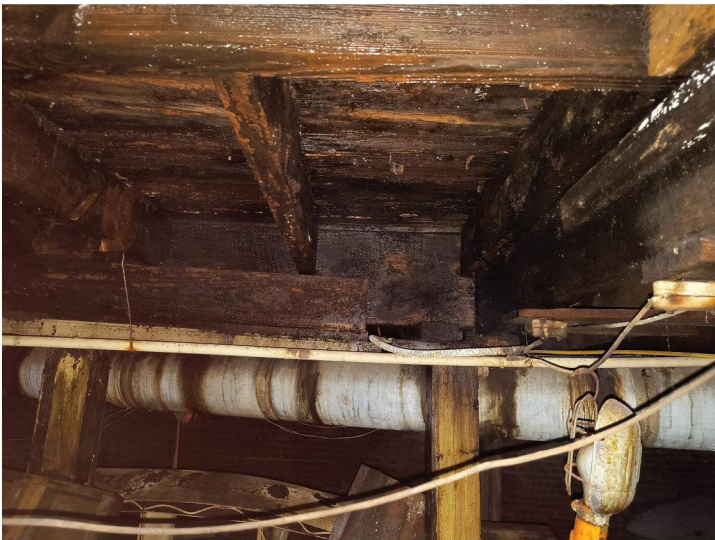
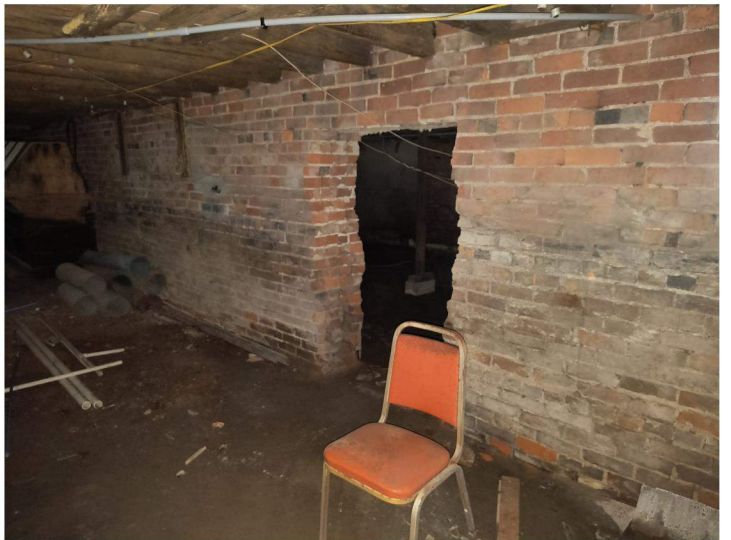
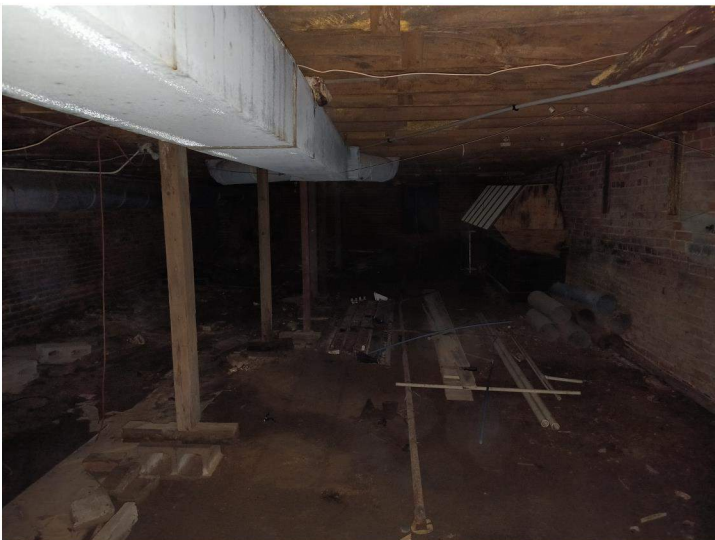
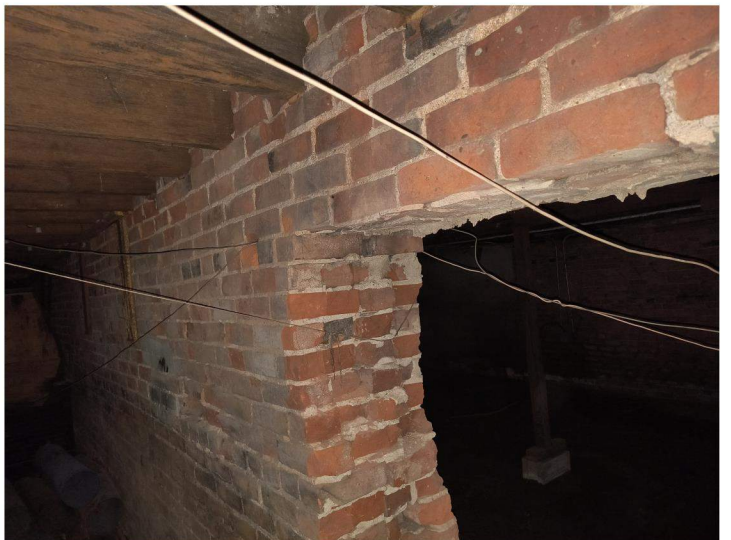
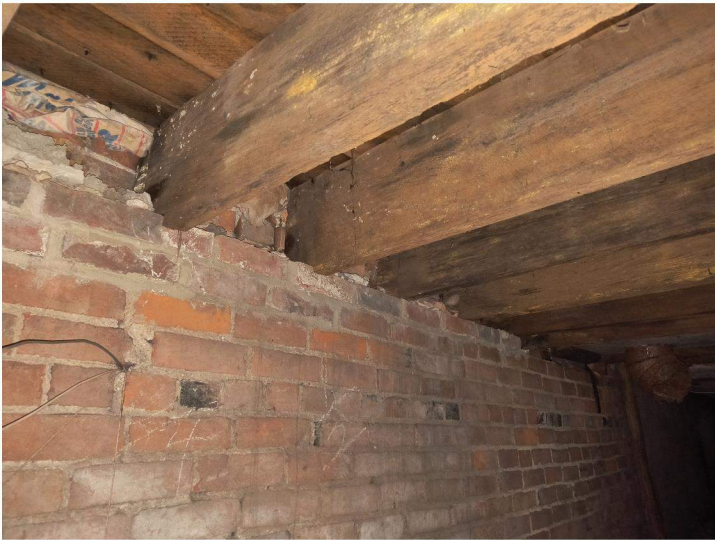
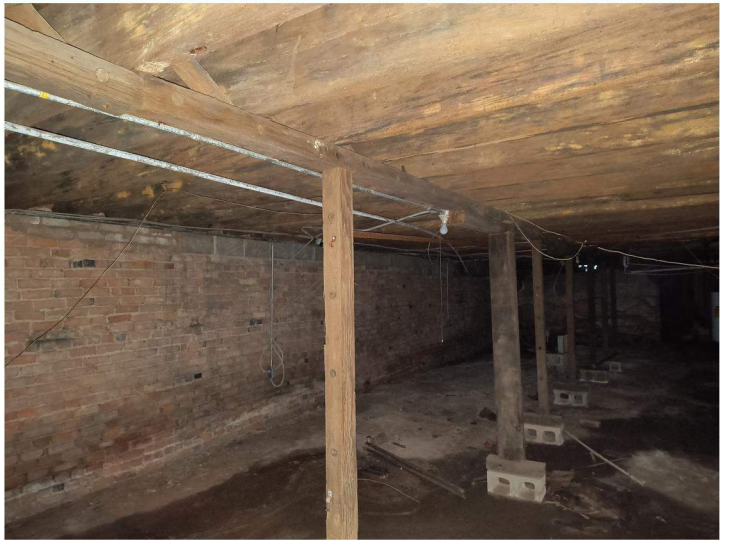
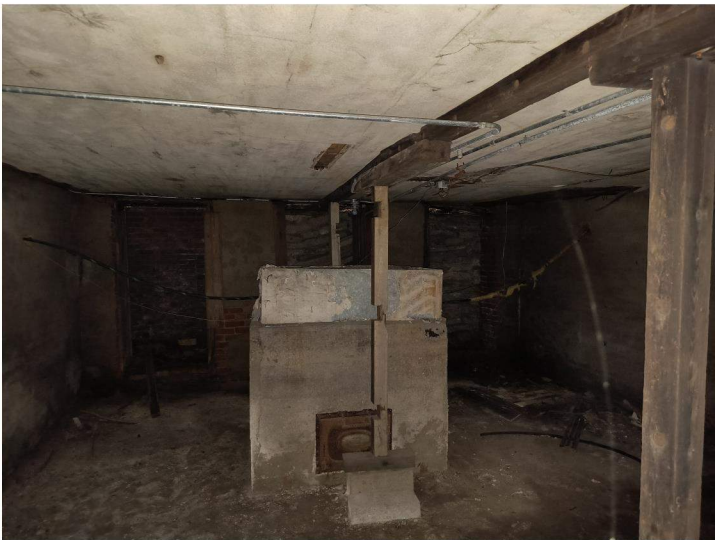
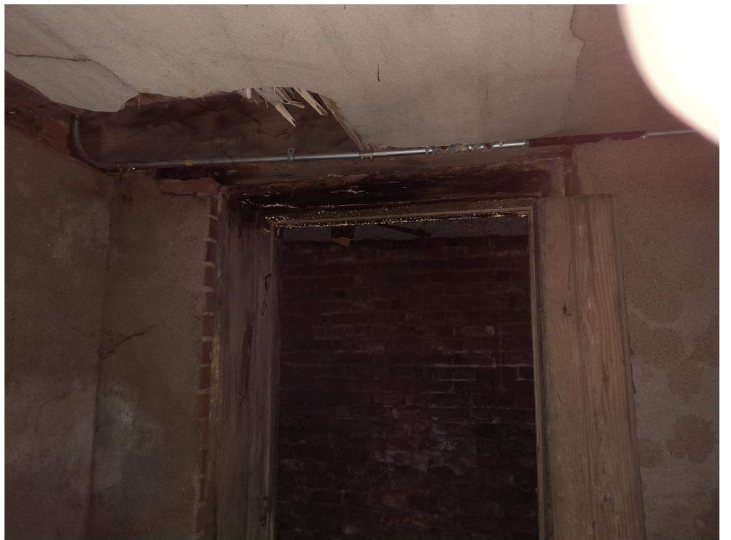
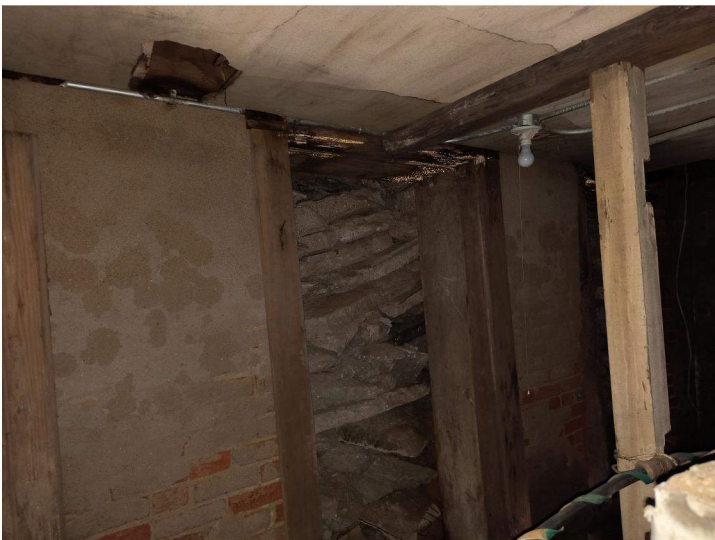
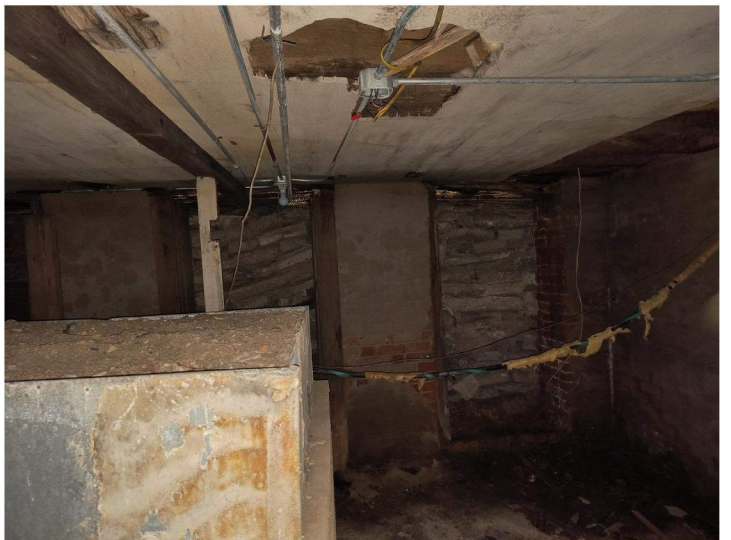
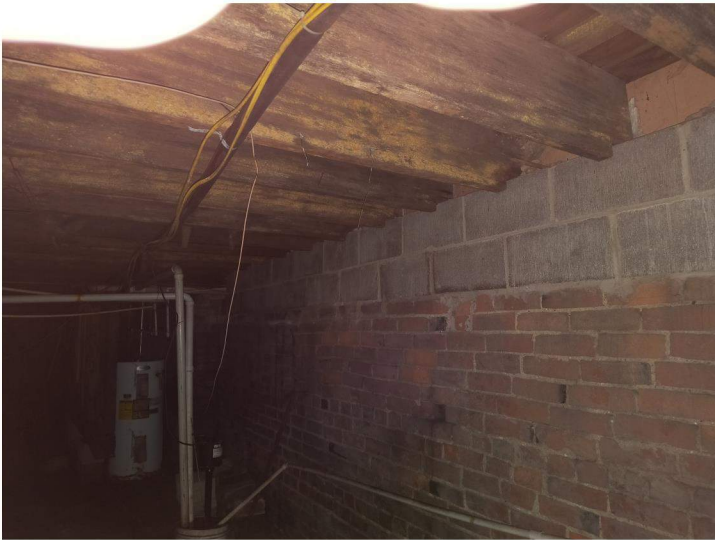
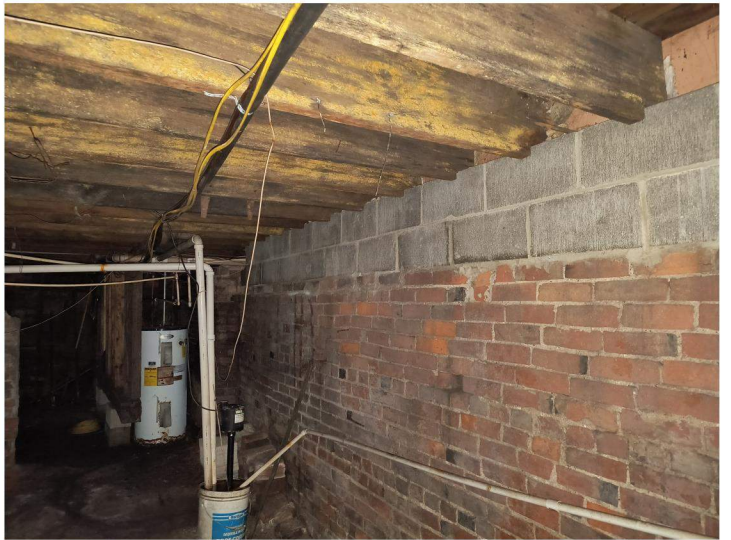
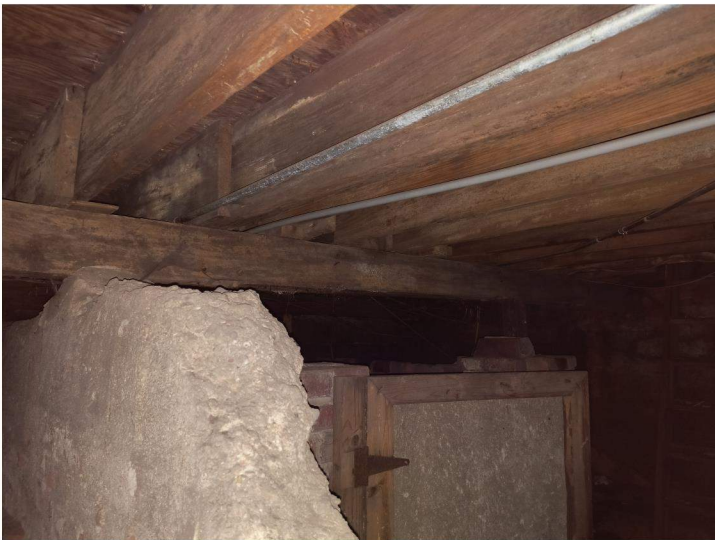
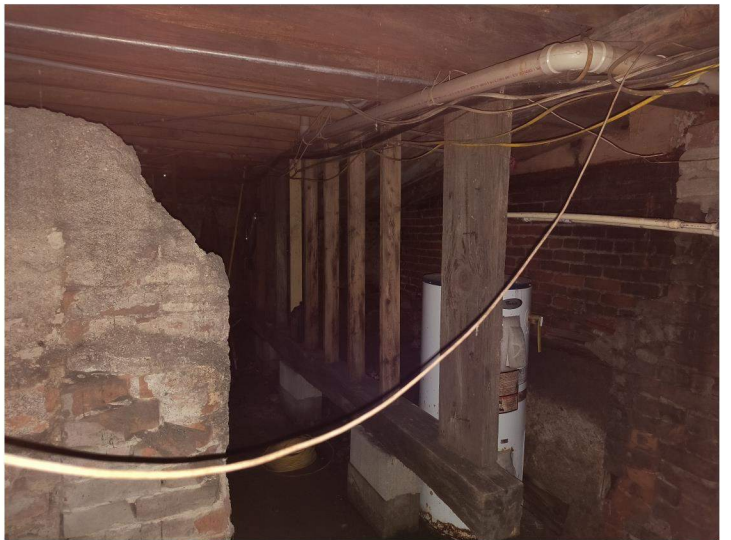
- The floor at the east building is soft due to water damage. The flooring and joists are saturated with water due to water infiltration from above.
- At the west side of the building, a large amount of debris was allowed to accumulate on the floor. The floor in this area has been shored up with timber as can be seen from the basement level.
- Some wood posts were installed with notches, rendering them inadequate to support the floor loads.
- The stairway from the first floor to the basement is soft and deteriorated from water damage. There is no wall or railing for fall protection around the stair opening.
- See photos 24 through 40.

4. Replace first-floor sheathing and floor wood joists that have been damaged, including the stairway into the basement. It is estimated that approximately 650 SF of the first-floor structure may have to be replaced.

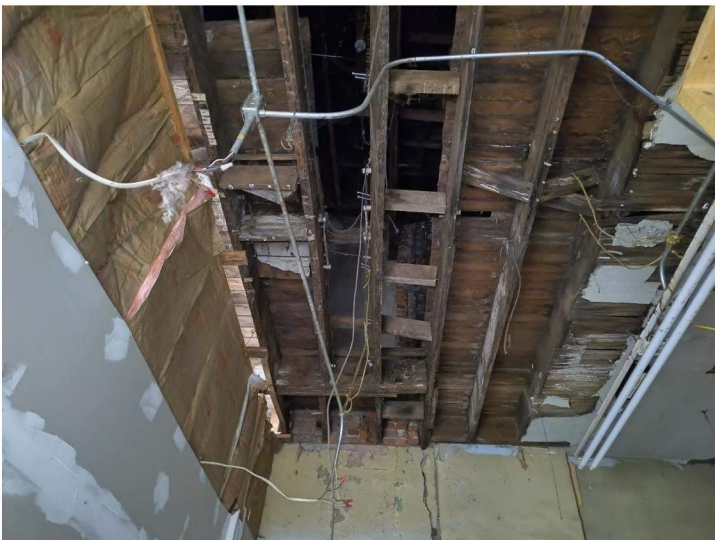
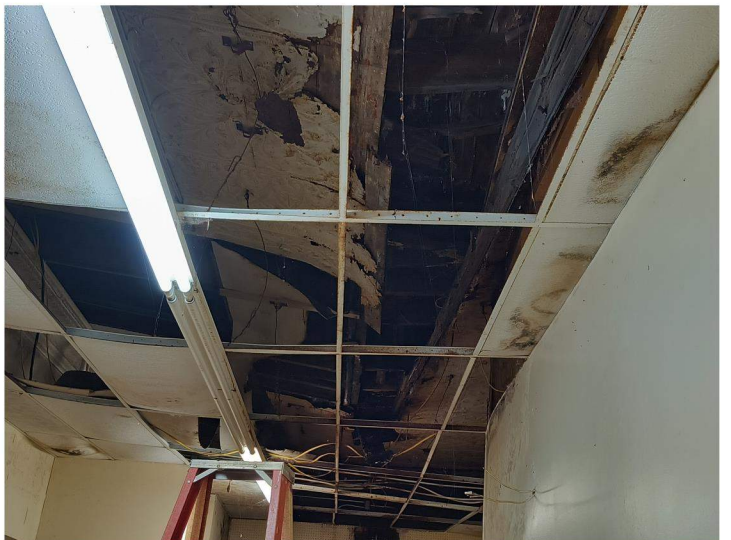
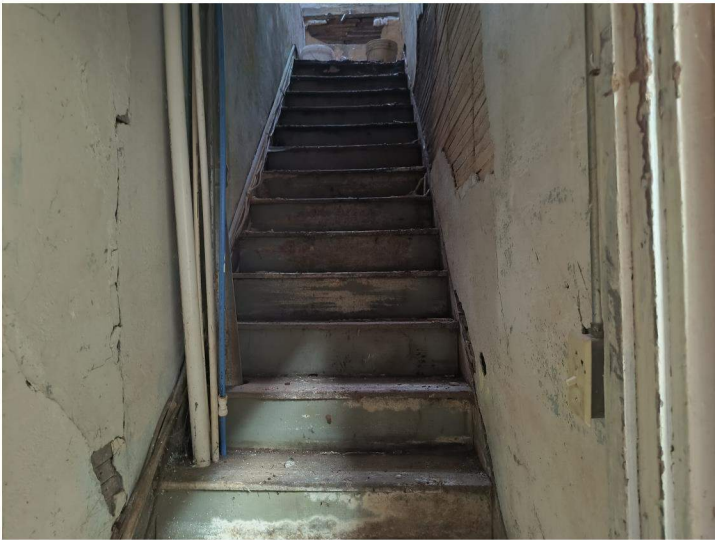
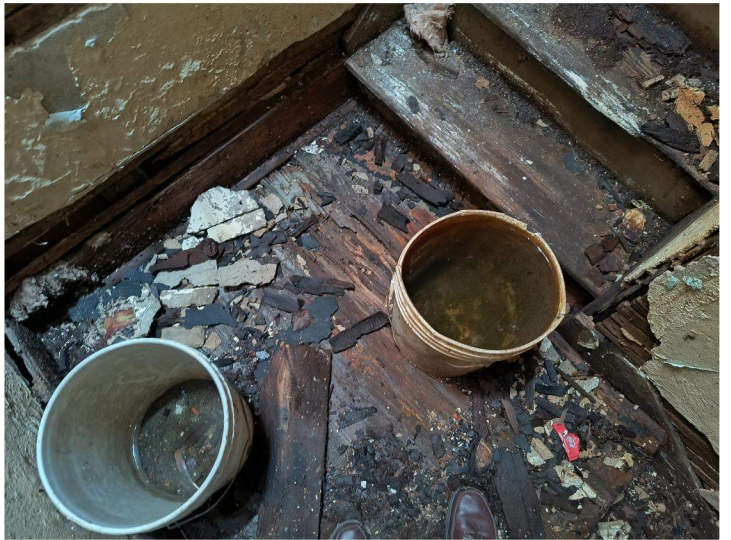
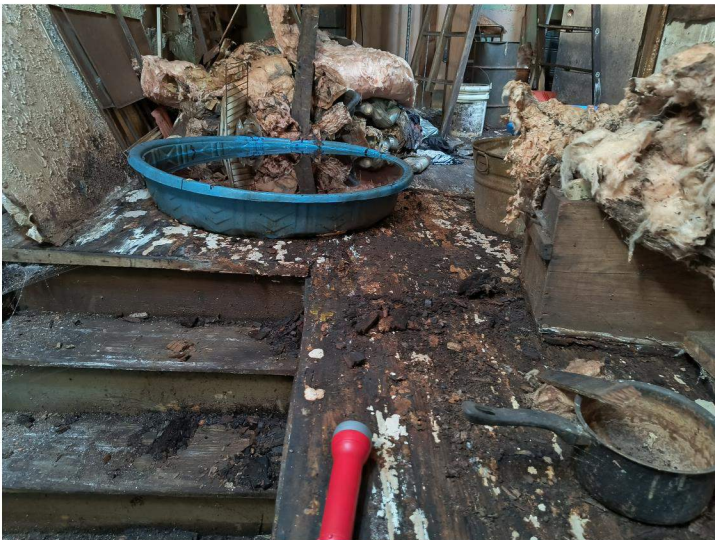
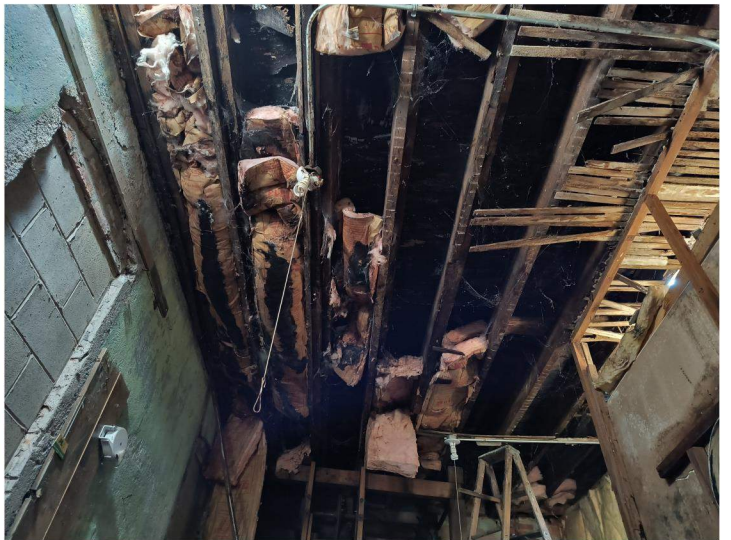
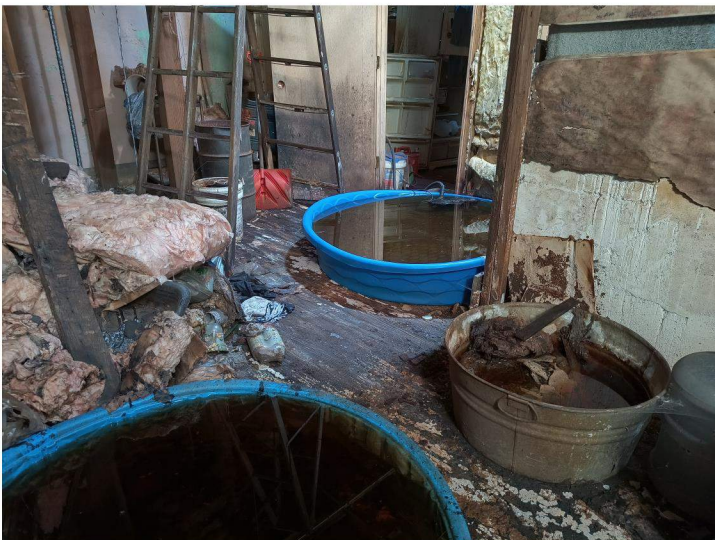
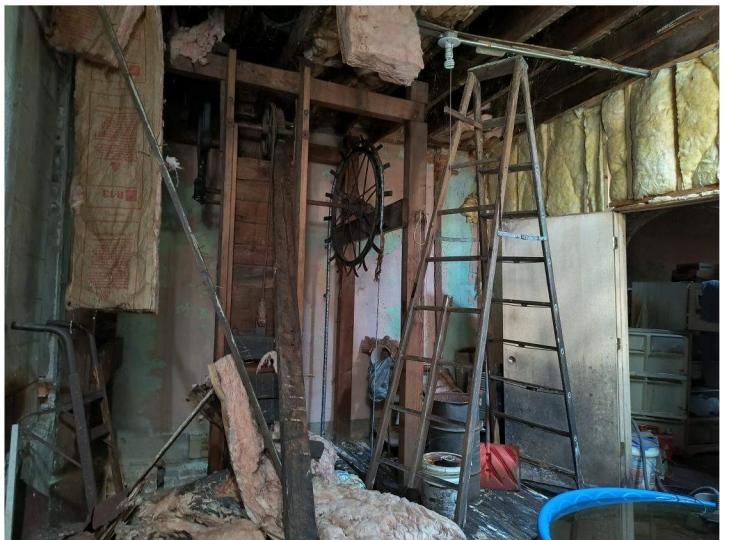
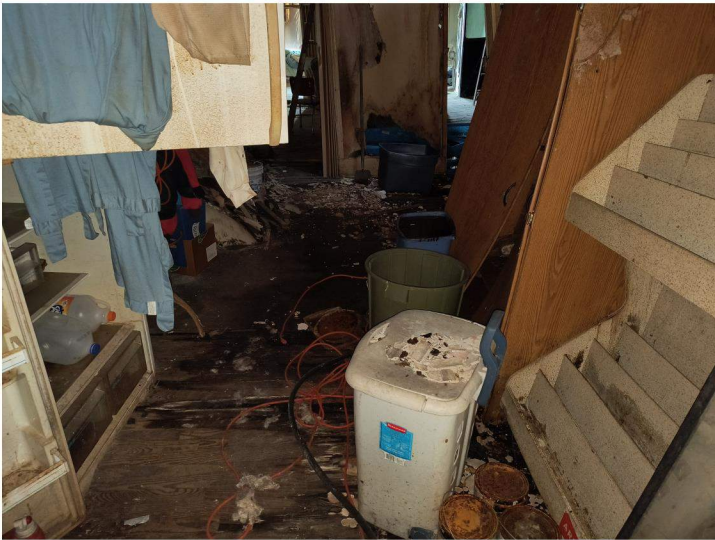
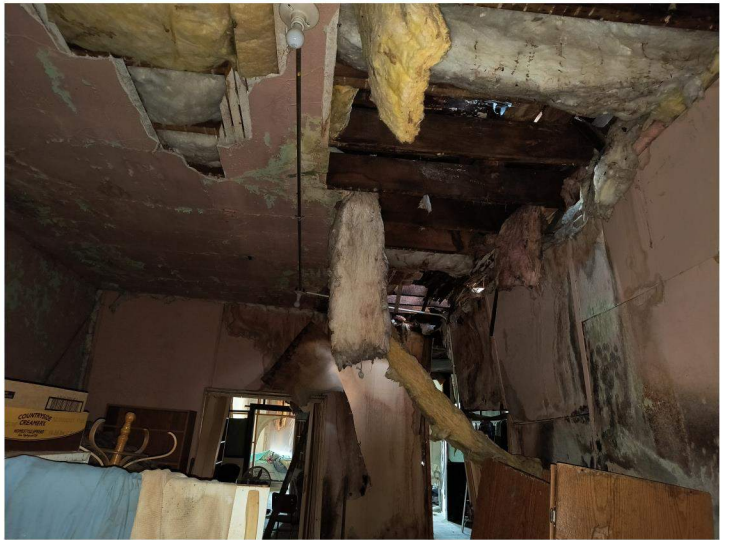
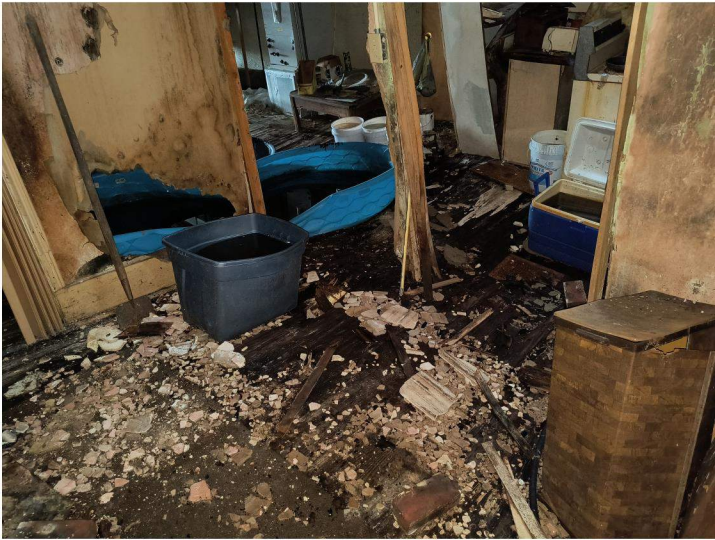
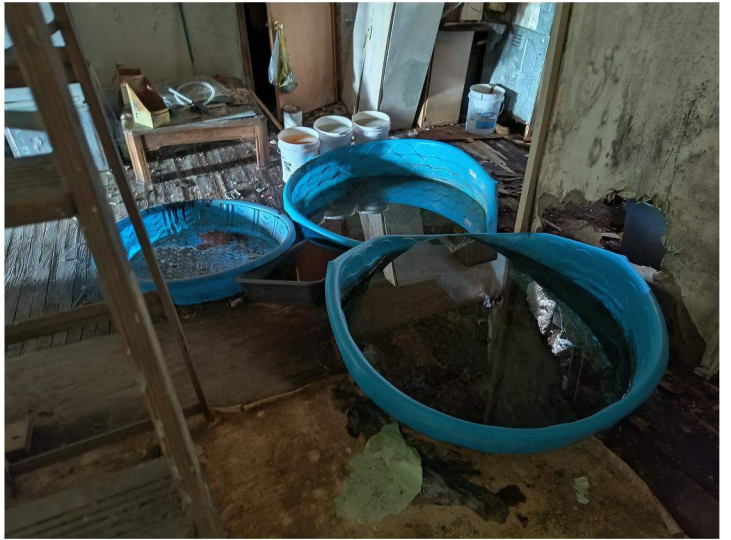
- The second floor at the east building has very severe sagging and deterioration due to the water damage.
- Several plastic pools and buckets on the second floor were used to collect water infiltrating from the deteriorated roof. This has added additional loads to the second-floor framing and caused some wood joists to fracture and completely fail.
- It appears that some efforts were made to partially support the second-floor framing.
- There are several locations where the floor sheathing boards are missing.
- The stairway from the first to the second floor is soft and deteriorated from water damage.
- See photos 41 through 52.

- Remove all pools and buckets full of water on the second floor to reduce the stress on the existing floor framing.
 - Remove all debris on the first floor at the northwest area of the building to reduce the stress on the existing floor framing.

3. Replace second-floor sheathing and floor wood joists that have been broken or damaged due to water infiltration including the stairway. It is estimated that approximately 1500 SF of the second-floor structure may have to be replaced.

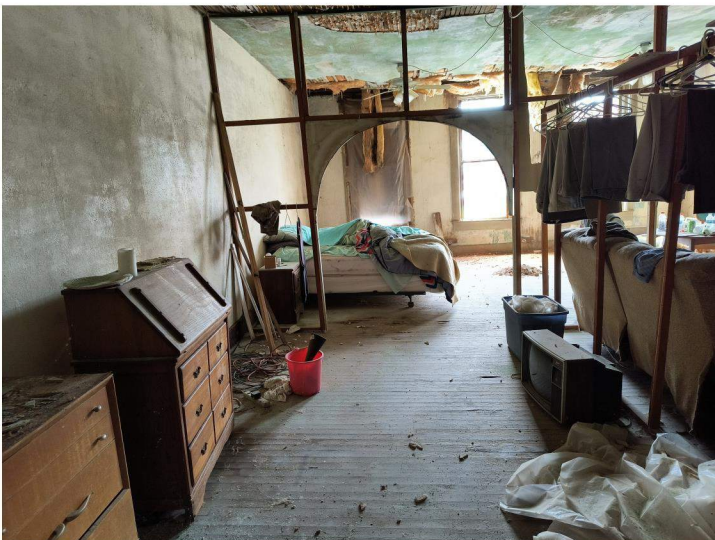
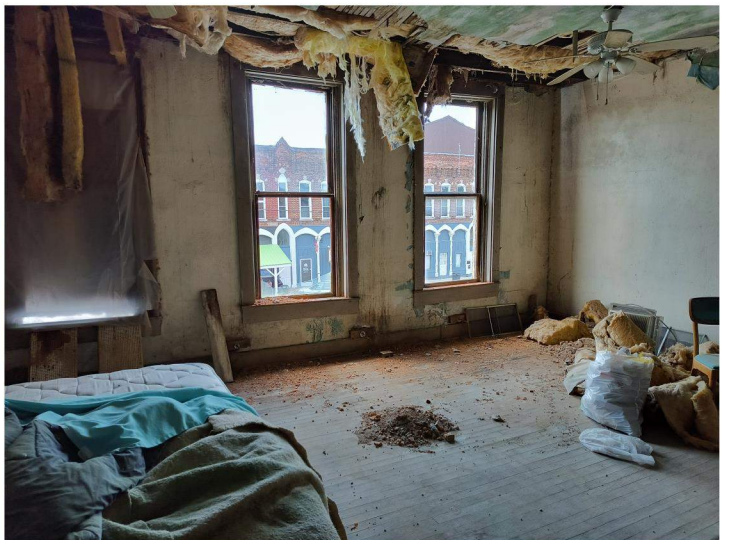
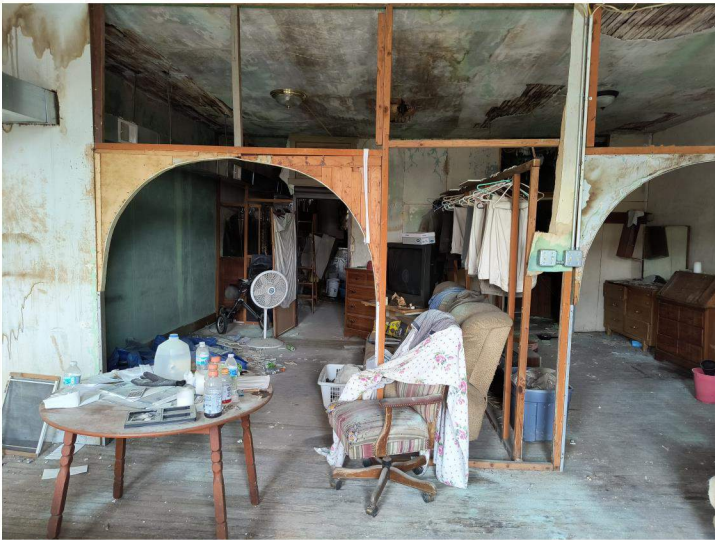
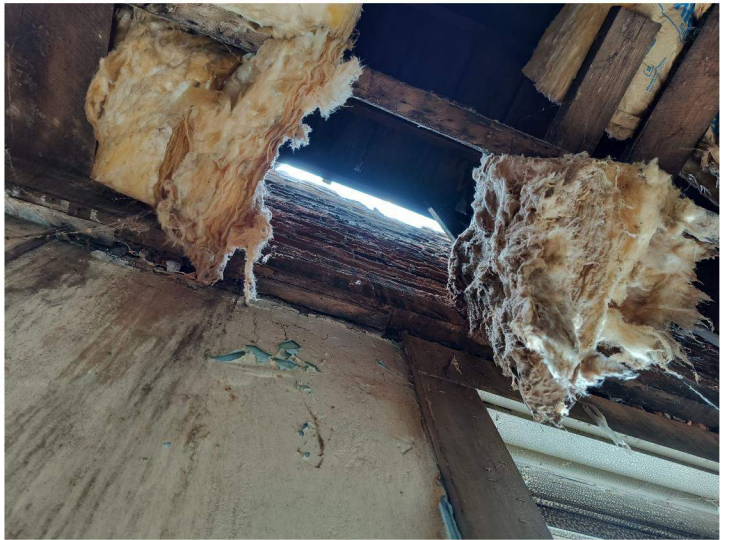
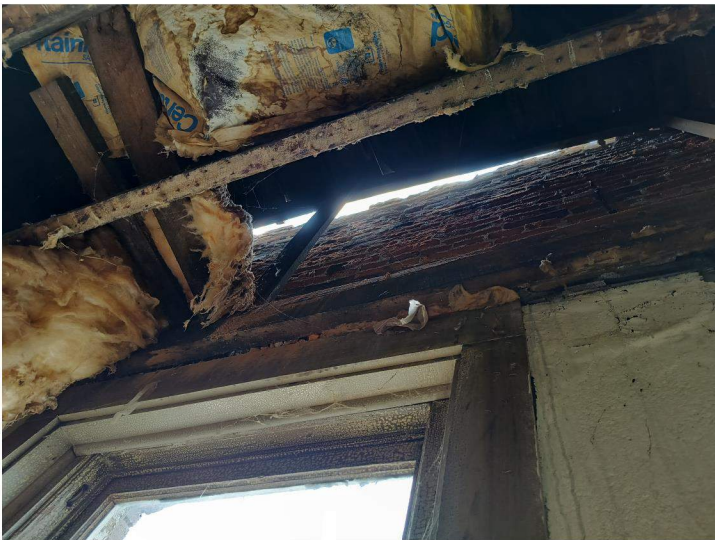
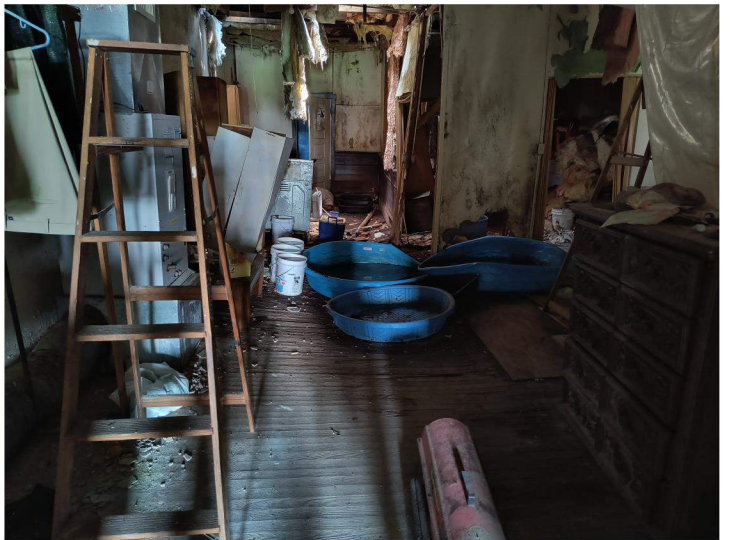
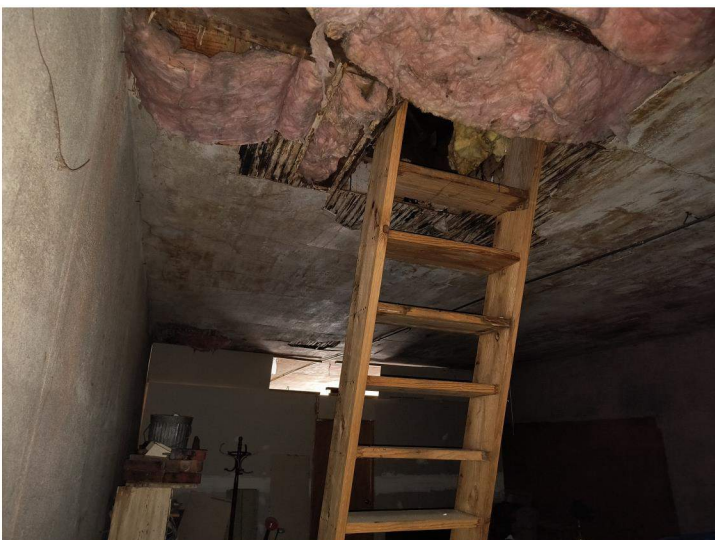
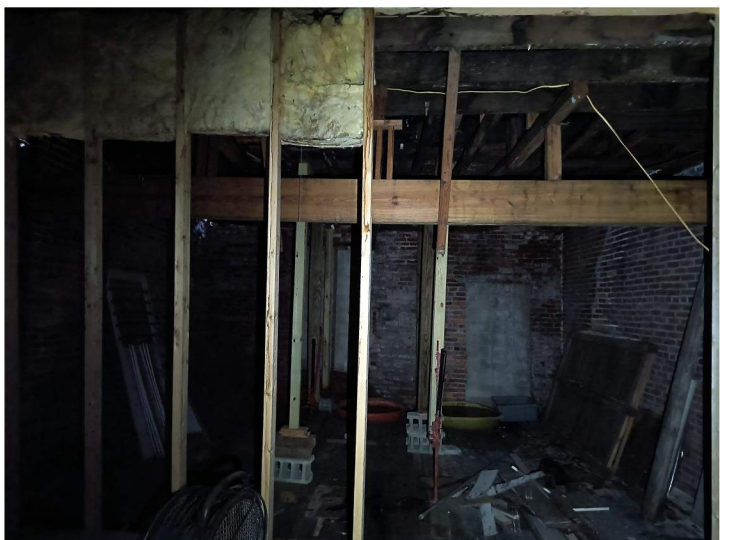
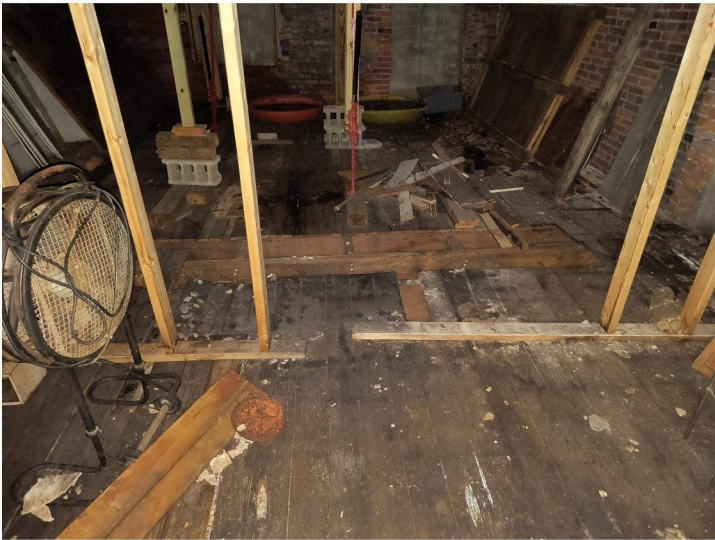
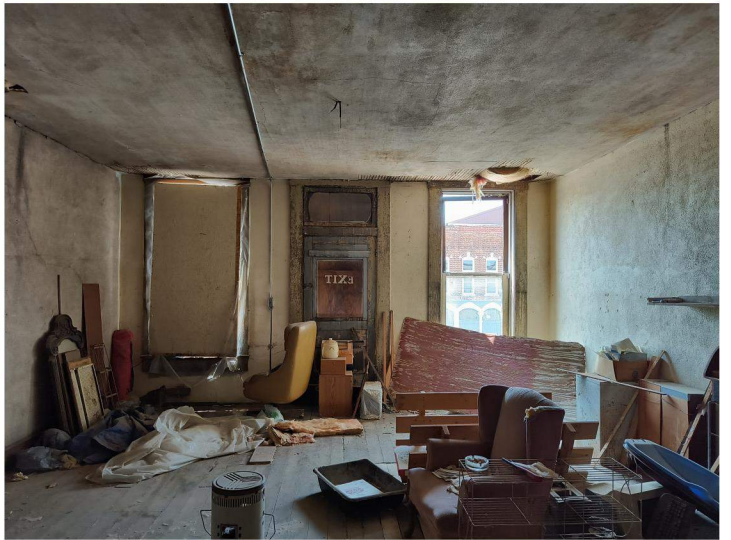
- There are several locations where the roof sheathing and roof rafters have deteriorated due to water damage. Daylight can be seen at several locations. The roofing and ceiling material are deteriorated in many locations.
- There are some locations at the northwest side of the building where shoring on the second floor was used to support the roof rafters.
- See photos 53 through 69.

1. Immediate action is required to resolve some of these issues. These measures are temporary until permanent repairs are implemented.
 - Cover any roof opening where there is water infiltration to reduce additional damage to the roof and levels below.

- See items 2 through 10 below for permanent repairs recommendations.
2. Replace roof sheathing and roof rafters that have been damaged due to water infiltration. It is estimated that approximately 1500 SF of roof structure may have to be replaced. It is difficult to see certain areas due to existing ceiling finishes.
