June 6, 2023

Re: Structural Condition Assessment
Smith Building
113 East Main Street
Thorntown, IN

CE Solutions' Project No: 23-137

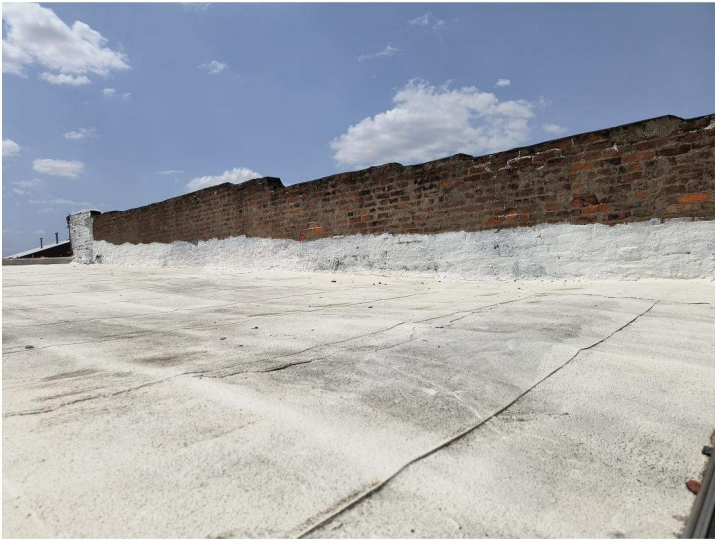
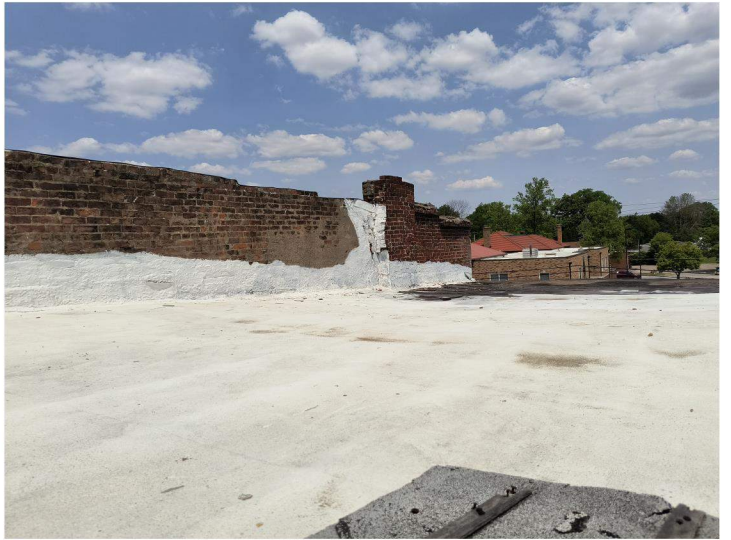
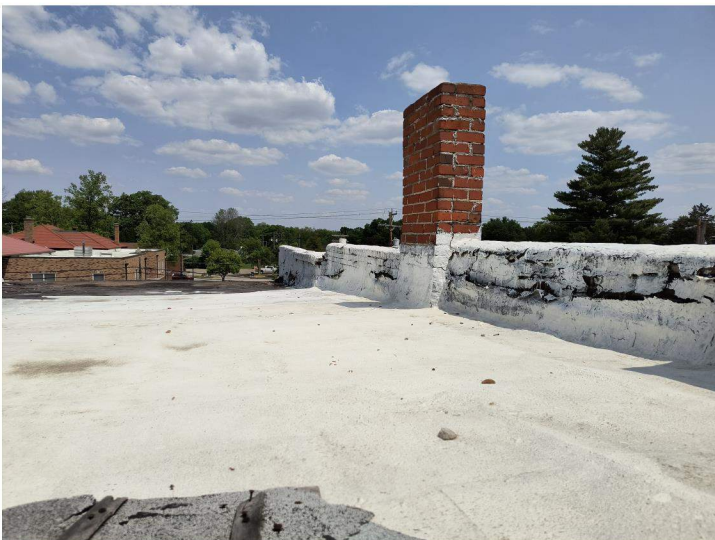
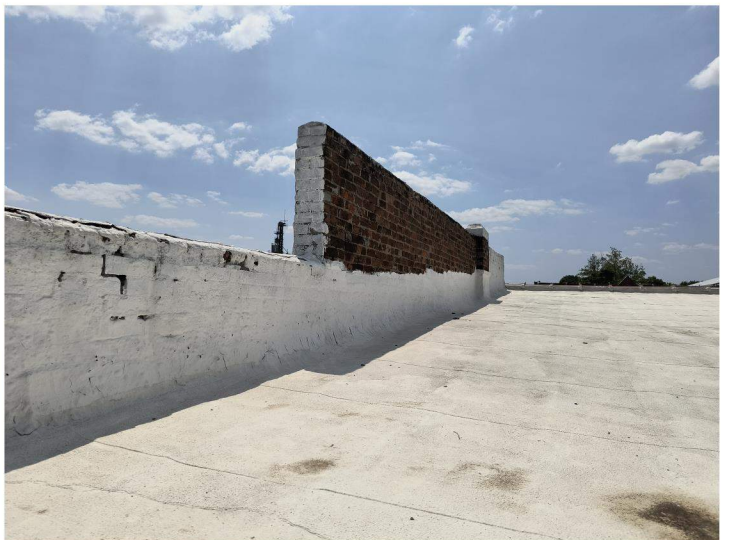
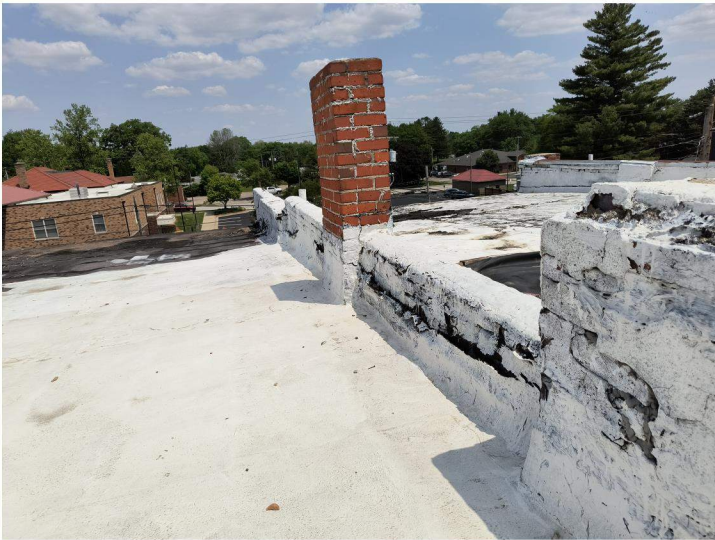
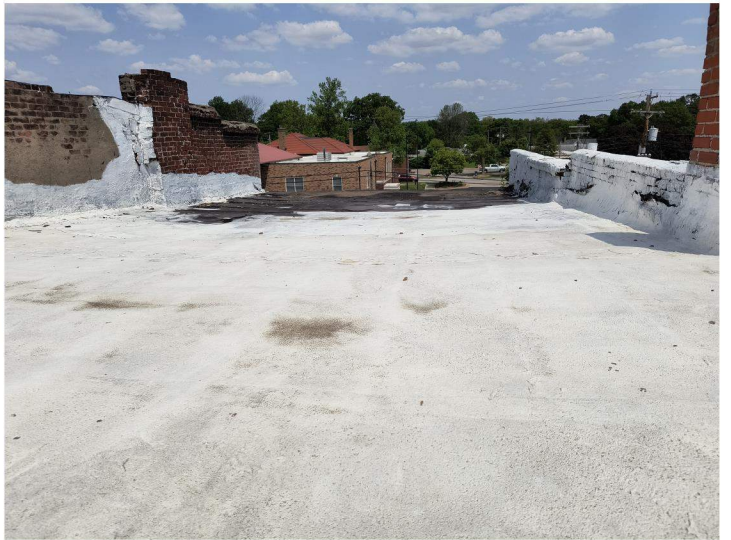
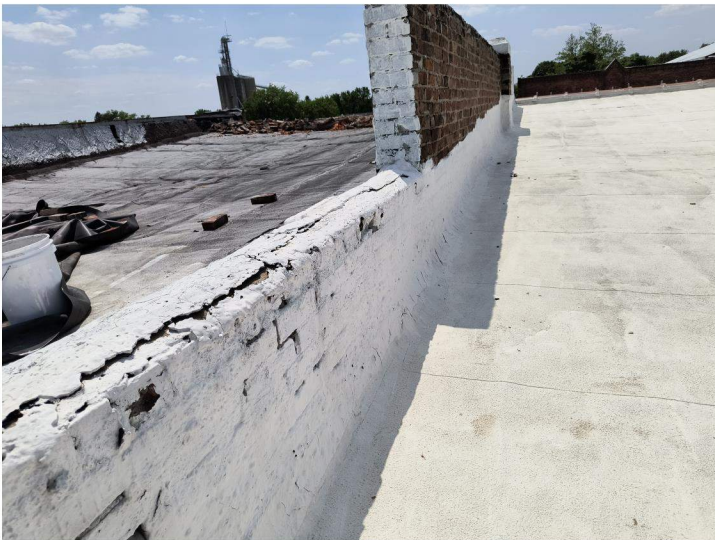
- There are several locations where the roof sheathing and roof rafters have deteriorated due to water damage. Daylight can be seen at several locations. The roofing and ceiling material are deteriorated in many locations.
- There are some locations at the northwest side of the building where shoring on the second floor was used to support the roof rafters.
- See photos 53 through 69.

- The brick wall parapets above the roof have deterioration at the brick mortar joints and at the brick wall caps. Part of the parapets are painted, so it is difficult to assess the extent of the deterioration.
- The flashing against the brick wall is also deteriorated in several locations allowing moisture and water to infiltrate down into the building space.
- See photos 63 through 69.

- See items 2 through 10 below for permanent repairs recommendations.
2. Replace roof sheathing and roof rafters that have been damaged due to water infiltration. It is estimated that approximately 1500 SF of roof structure may have to be replaced. It is difficult to see certain areas due to existing ceiling finishes.

10. Repair and tuck point deteriorated mortar brick joints at the side wall parapets. It is estimated that approximately 550 SF of brick wall parapets where mortar joints may have to be repaired.
